Surgical and Non-surgical Repair of Iatrogenic and Carious Perforation using Biodentine: A Case Report

CASE REPORT 1:

CASE REPORT 2:

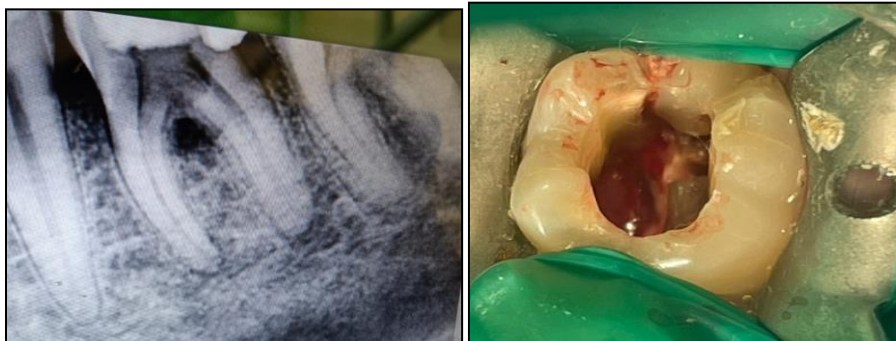
Fig.1: A) Preoperative radiograph, B) After removal of restoration

After administration of local anesthesia using 2% lignocaine with 1:100,000 epinephrine, 36 was isolated with rubber dam. The composite restoration was removed followed by access cavity preparation. After coronal pulp removal, bleeding was observed from carious perforation at the mesiolingual aspect of pulpal floor [Fig.1: B]. All root canal orifices were located and working length was determined with no. 10K file (Dentsply Maillefer, Ballaigues, Switzerland) using Propex Pixi™ (Dentsply Maillefer, Ballaigues, Switzerland) and confirmed by radiograph [Fig.2: A]. Pulp extirpation and initial canal preparation till Protaper S1 was done, after which calcium hydroxide was placed in the canals as intracanal medicament and at the perforation site and the patient was recalled after a week. In the subsequent visit, biomechanical preparation

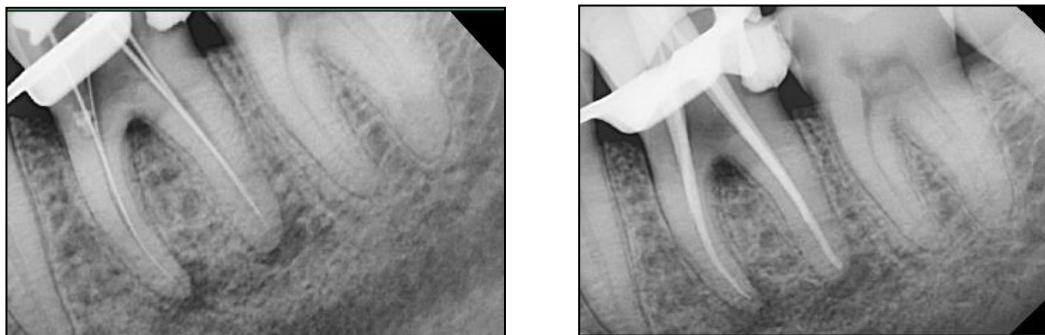
Fig.2: A) Determination of Working Length, B) Obturation

was completed using Protaper Gold files (Dentsply Maillefer, Ballaigues, Switzerland). The mesiobuccal and mesiolingual canals were prepared till F1 and the distal canals were prepared till F2. The canals were then obturated with corresponding gutta percha cones [Fig.2: B]. To repair the furcal perforation, AB Gel (Healthium, Kandivali, Mumbai) was placed in the perforated area [Fig.3: A]. Then Biodentine (Septodont, Saint-Maur-des Fosses Cedex, France) was manipulated by mixing the 1 capsule of powder with 5 drops of liquid in the triturator for 30 seconds. The mix was then carried by using an amalgam carrier to the perforation site condensed passively with finger plugger (Dentsply Maillefer, Ballaigues, Switzerland) followed by radiographic verification [Fig 3: B]. After setting of biodentine, post endodontic composite restoration was done (Coltene Brilliant NG, Langenau, Germany) [Fig.3: C]. PFM crown was placed in the subsequent appointment.

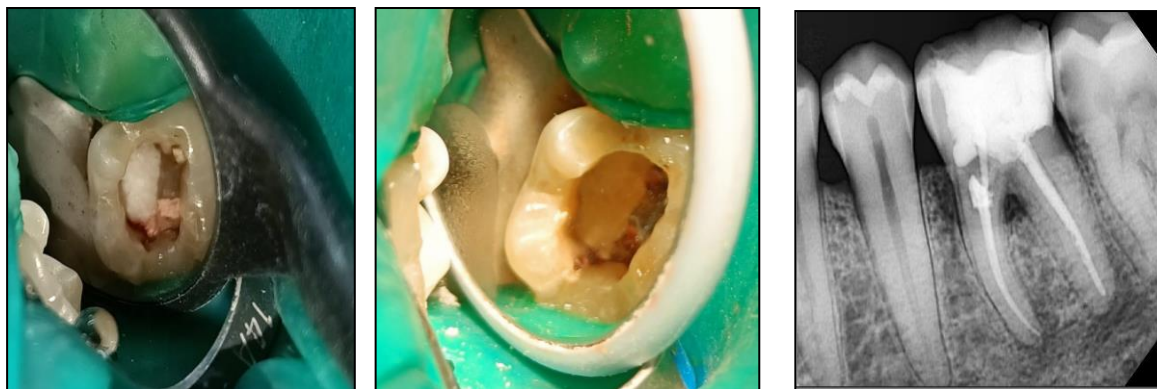
Fig.3: A] ABGel Placement, B] Repair with Biodentine, C] Post endodontic restoration

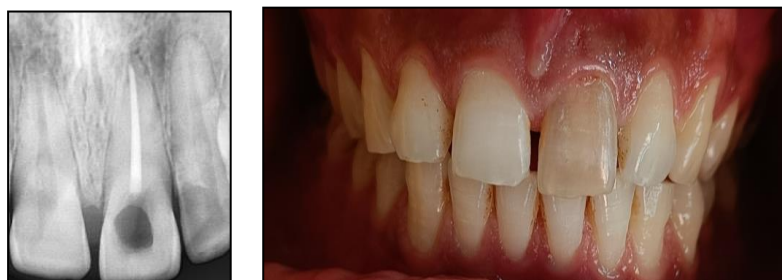
Fig.5: A] Preoperative radiograph, B] Preoperative Clinical Picture

A 20-year-old male reported with a chief complaint of mild pain in upper anterior tooth. The patient gave a history of root canal treatment done 1 year back however visited a dental practitioner for discolored upper anterior tooth a week back for which he got some treatment done; post which the patient developed mild pain. On clinical examination, it was found that 21 was discolored, temporarily restored and gingival inflammation at the cervical region was seen [Fig 5:A] The radiograph revealed obturation of root canal space with no significant apical pathosis [Fig 5:B]. On removal of temporary restoration, bleeding was observed in the access cavity and on further evaluation, perforation was seen in bucco-cervical region which was an apex locator. A CBCT was then advised to the patient, the axial and coronal sections revealed a perforation of size 5X3mm in crestal region of tooth extending in bucco-lingual direction [Fig.6]. A surgical perforation repair was planned and an

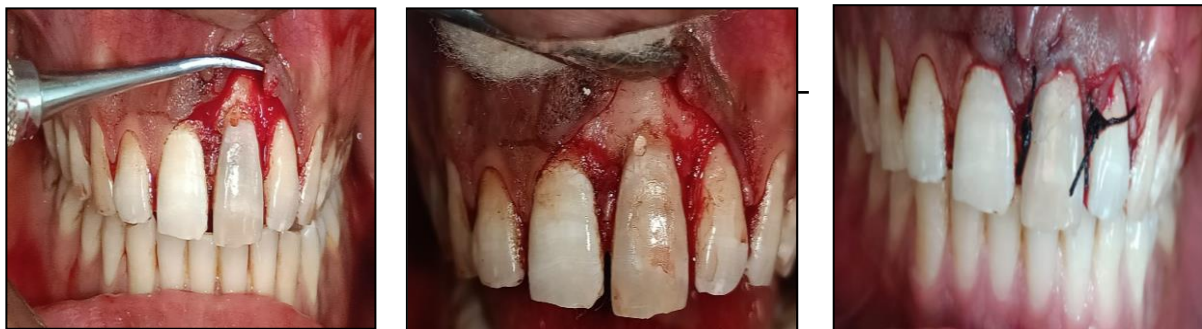
Fig.7: A] Perforation site after raising the envelop flap, B] Repair with Biodentine, C] Suturing of the flap

After the area was anaesthetized with 2% lignocaine and 1:100,000 epinephrine, an envelope flap was raised to expose the perforation site. After isolating the perforation site, perforation repair was done using Biodentine (Septodont, Saint-Maur-des Fosses Cedex, France) which was manipulated as discussed in Case 1. The mix was then carried by using an amalgam carrier to the perforation site and finger plugger (Dentsply Maillefer, Ballaigues, Switzerland) was used to condense and fill the perforation canal with the mix [Fig.7: B] and the access cavity was sealed with RMGIC (GC Fuji li 2 LC, Tokyo, Japan). The raised flap was then sutured back with 5-0 silk sutures (Synthalin, Bangalore, India) [Fig.7: C] and post operative instructions were given to the patient. After a week, sutures were removed [Fig. 8] and 6 months follow up showed satisfactory healing.

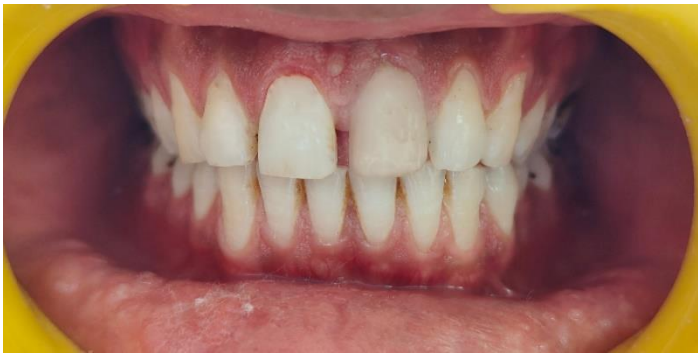
Fig.8: After suture removal
