Management of Embedded Lingual Holding Arch (Orthodontic Appliance) in Mandibular Arch by Electrocautery: A Case Report

Case Report: A 19-year-old female patient, referred from the Department of Orthodontics to the Department of Periodontics, presented with a primary complaint of pain during chewing. The pain was attributed to an embedded lower lingual arch, an orthodontic appliance, which had become lodged due to a failure in the orthodontic treatment. Upon intra-oral examination, bands were observed on the lower first molars in both the right and left quadrants, with no visible signs of inflammation or infection. Radiographic assessment, specifically in the occlusal view, revealed the presence of a wire encircling the bone, indicating the orthodontic appliance's abnormal positioning.

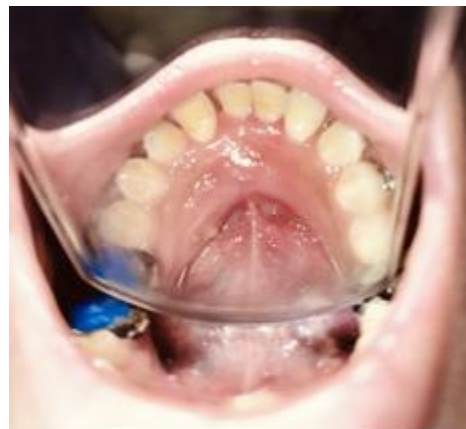
Fig 2: intra-oral examination shows presence of lingual holding arch in lingual mucosa

On further findings, there was no swelling or redness around, but the presence of wire fell on palpation. We examined the case and diagnosed a wire embedded in lingual mucosa with the help of a radiograph and decided to remove it surgically with electrocautery.

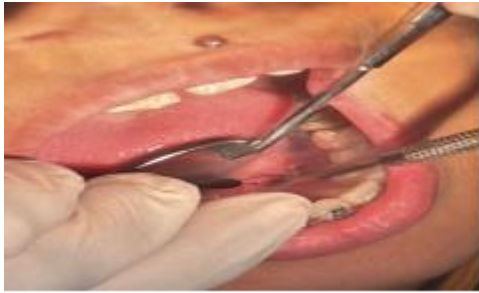
The incision is given from the left side 2nd premolar up to the right side 2nd premolar following the shape of an arch and wire is exposed and retrieved with the help of a P24G instrument.

Blood investigations are advised for the patient along with phase 1 therapy including pre-antibiotic prophylaxis. After 1 week of phase 1 therapy (scaling and post-hygiene instruction), a patient came to our department for a surgical procedure. Before proceeding with surgery patch test (hypersensitivity reaction with LA) should be performed on the patient. Local anesthesia was infiltrated at the affected site and an incision was given with the help of electrocautery avoiding damage to the lingual nerve.

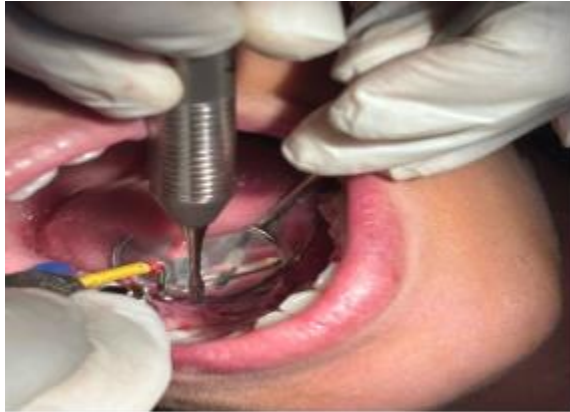
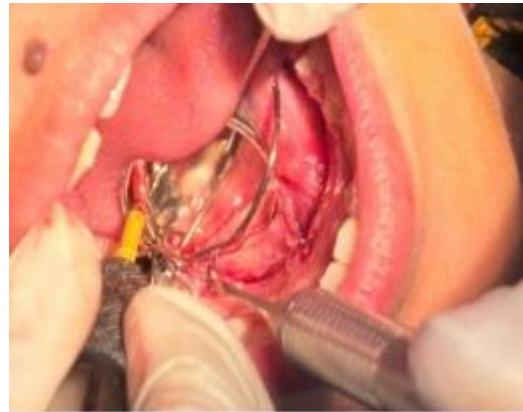
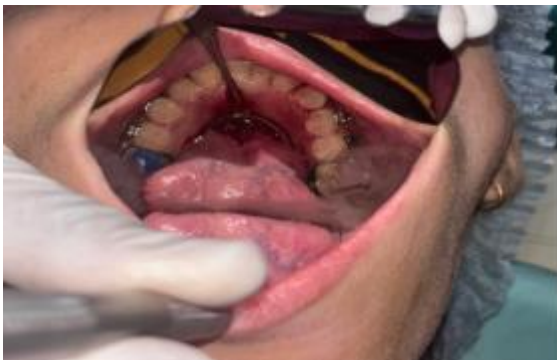
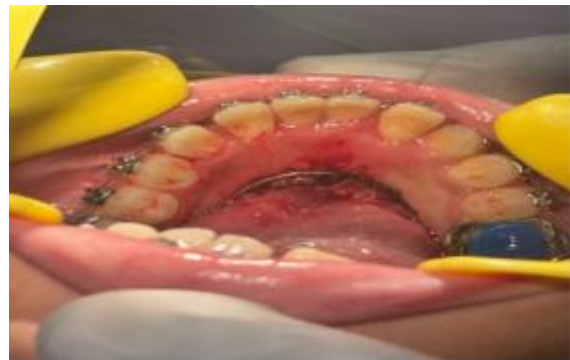
Fig: 3 showing exposed lingual arch wire after incision

Welded bands on 1st molar and labially placed wire should be removed under the guidance of an orthodontic surgeon.

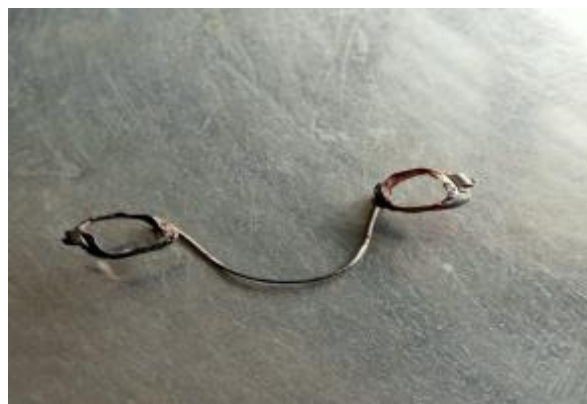
Fig: 4 post operative photograph of lower lingual arch appliance

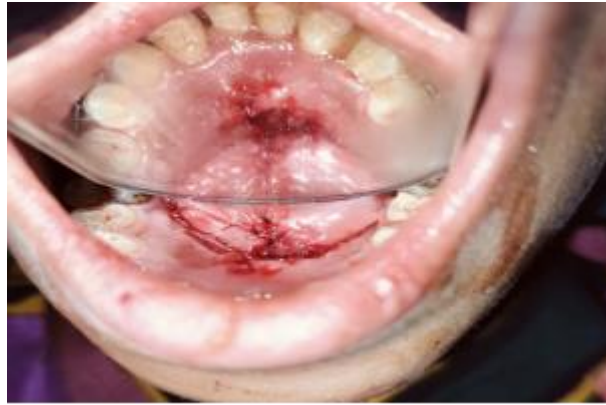
Fig: 5 intra operative photograph showing placement of suture.

After successful retrieval of appliance resorbable sutures were placed avoiding tissue tearing.

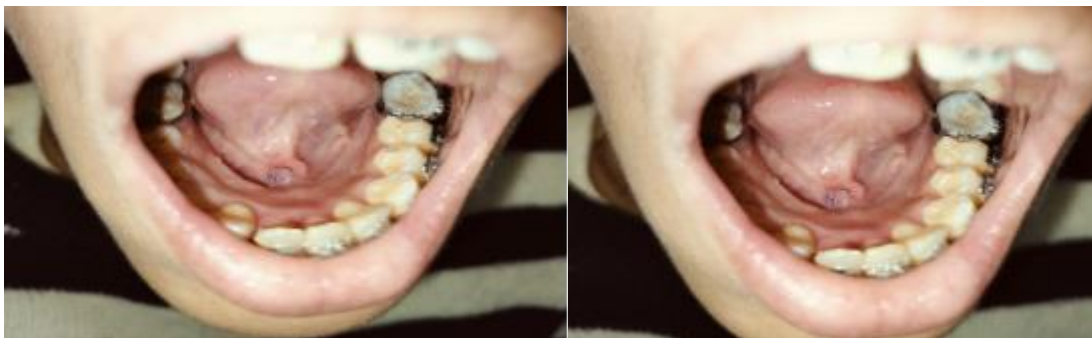
Post operative instructions and medicines prescribed to patient and recalled after a week for follow up. After a week follow up picture was taken and patient was satisfied

with the treatment having no complaints of any type of pain while chewing.

Fig:6 post operative follow up pictures
