The Founkama Micro-Dam: A Hydraulic Structure to be Preserved, Guinea

Designed to irrigate rice paddies and improve local agricultural production in the Niger River plain near Faranah, this article focuses on the Founkama micro-dam, a hydraulic structure located in the urban commune of Faranah, Guinea. To study this structure, several field missions were conducted in the Niger River plain near Faranah, during both the dry and rainy seasons. Built on the Niger River in 1981, the Founkama micro-dam irrigates 150 hectares of the Niger River plain near Faranah. Currently, water resources are becoming scarce in the Niger River plain near Faranah during the dry season, hindering the development of agro-pastoral activities, as the micro-dam is abandoned and its infrastructure is dilapidated. These difficulties justify the validity of this study, which focused on the preservation of the Founkama micro-dam in the commune of Faranah, Guinea. The results showed that the observed deterioration of the structure could be due, on the one hand, to the aging of the materials, manifested by exposed aggregates on the upstream face as well as

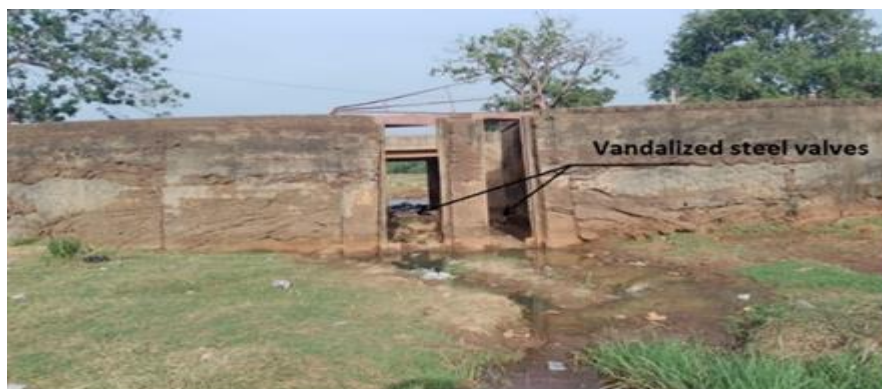
The Founkama micro-dam has thus far withstood numerous floods, thanks to its dam, which is approximately 100 m long and 3.00 m high (Figure 3). It is equipped with two steel gates, each measuring 0.95 m x 2.85 m, positioned midway along the dam (Figures 3, 4, and 5). These gates are crucial for water management. They allow for

regulating the reservoir level, releasing floodwaters (for safety), and draining the basin (for sediment flushing). They ensure safety by withstanding high pressures. It should be noted that during a flood, all the gates are opened to allow water to flow in. For reservoir maintenance, releasing water from the dam through the gates is essential.

Figure 5: Two vandalized metal valves at the dam of the Founkama micro-dam (Photo. Babilas Hountondji, 2026).

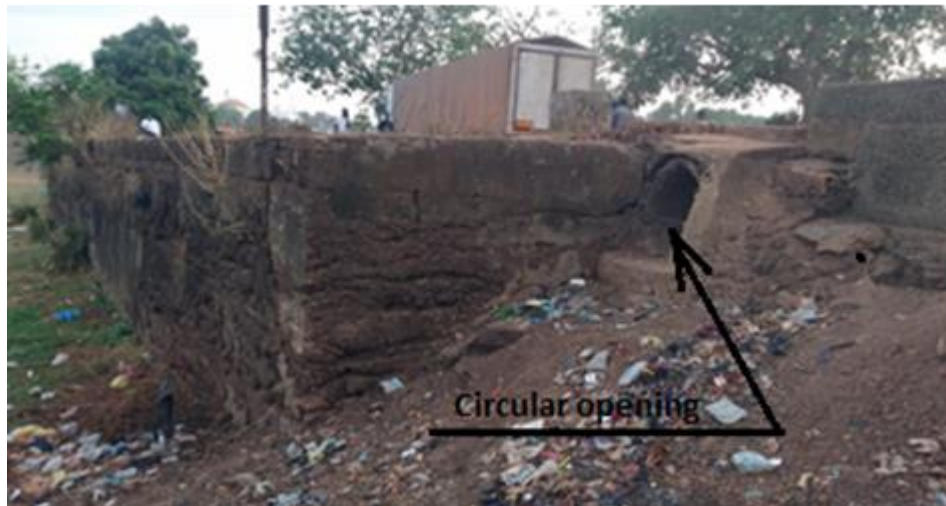
The micro-dam is also equipped with a circular orifice with an internal diameter of 40 cm, located at the top and end of the right-hand side of the dam relative to the two gates (Figures 3, 4, and 6). When the reservoir's capacity is reached, water flows

out through this orifice. In this case, the orifice replaces the spillway of a conventional dam. The micro-dam serves a dual purpose: first, to create a humid microclimate in a dry region; and second, to ensure continuous irrigation.

Figure 6: Circular evacuation opening at the level of the dike of the Founkama micro-dam (Photo. Babilas Hountondji, 2026).

On the other hand, the undersizing of the circular evacuation openings with an internal diameter of 40 cm which act as flood spillways, namely one (01) planned at the level of the Founkama micro-dam dike approximately 100 m long and 3.00 m high

(Figure 3), against nine (09) planned on the dike of a dam 50 m long and 1.50 m high (Figure 10 and 11), could also be the cause of the dissolution and erosion observed at the level of the body of the dike.

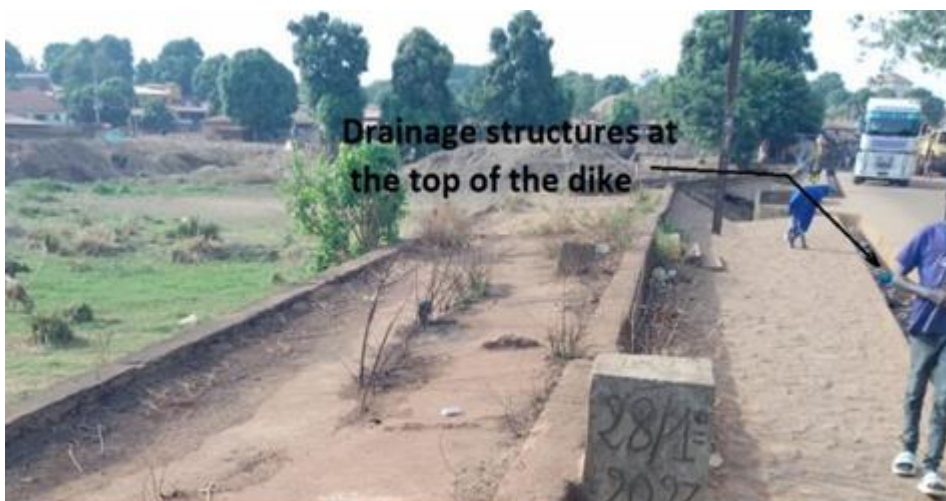
The crest of the micro-dam dike, 7 m wide, is a traffic lane equipped with small drainage structures such as convergents and

channels on both banks to facilitate the collection of runoff water during the rainy season (Figure 7).

Figure 7: Drainage structure at the top of the micro-dam of Founkama (Photo. Babilas Hountondji, 2026).

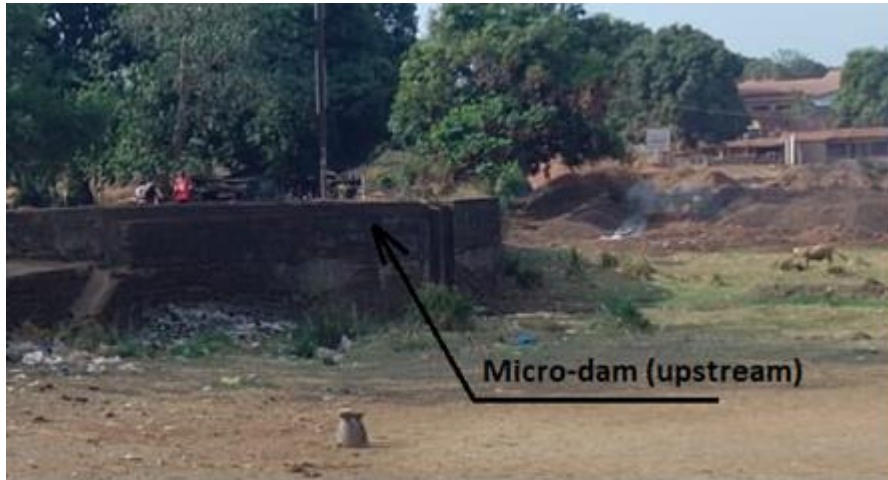
The depletion of the reservoir is the real problem with this hydraulic structure (Figure 8). Indeed, in the early 1960s, a few

motor pumps were introduced into the Faranah basin, but in the early 1980s, during the construction of the Founkama micro-dam, this method of water extraction accelerated. Furthermore, the socio-economic development of the Faranah municipality,

along with its rapidly growing population, led to the expansion of new agricultural land and housing in the town of Faranah. This was followed by a significant increase in the number of boreholes drilled. This

phenomenon impacted the water supply to the dam, as the groundwater level dropped dramatically, resulting in a decrease in irrigation water in order to prioritize drinking water supply in the region [5-6].

Figure 8: Drying observed at the level of the basin of the Founkama micro-dam (Photo. Babilas Hountondji, 2026).

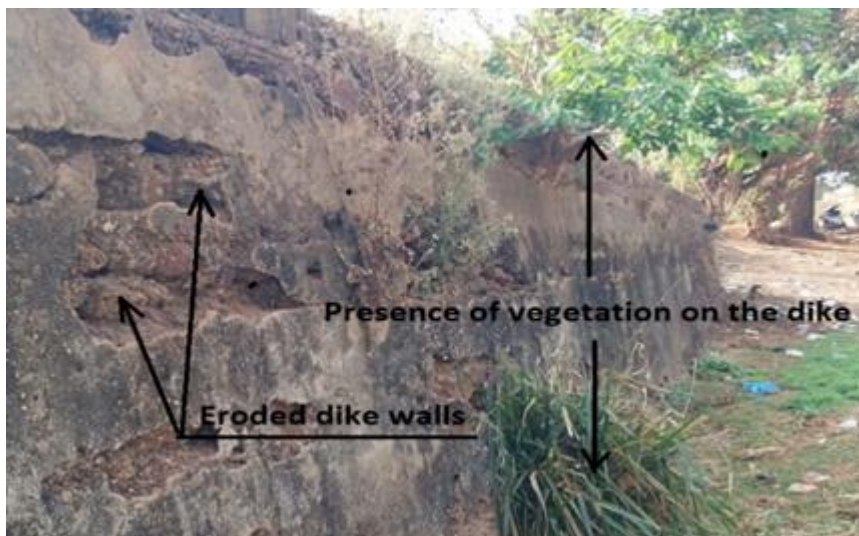
The degradation of reinforced concrete micro-dams and their associated structures pose a significant threat to their long-term viability. This degradation is primarily caused by water infiltration, design/construction flaws (cracking, poor concrete quality), and environmental factors such as floods, earthquakes, and material aging. Therefore, the appearance of degradation on the dam body of the

Founkama micro-dam is a major concern that could impact the structure's lifespan. Describing these phenomena is thus crucial for understanding and analyzing the degradation patterns affecting the structure. The degradation of the dam body could be attributed, in part, to material aging. This mechanism is manifested by exposed aggregates on the upstream face, as well as vegetation (Figure 9).

Figure 9: Vegetation presence and degradation observed on the Founkama micro-dam (Photo. Babilas Hountondji, 2026)

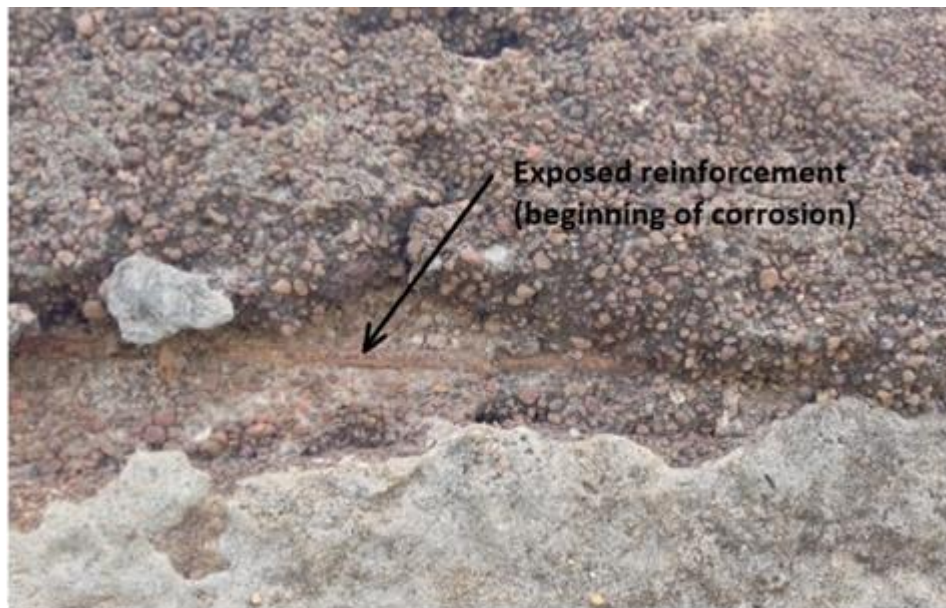
In the long term, the main effect of this mechanism is a loss of material through dissolution and subsequent erosion, exposing the reinforcement bars. Corrosion (Figure 12) accelerates damage, potentially leading, if the weight loss is significant, to a

substantial decrease in stability criteria. The dissolution of materials could induce an increase in the dam's permeability, leading to increased drainage flows (fueling the dissolution mechanism) and uplift pressures (further reducing stability criteria).

Figure 12: Dissolution and erosion of the material expose the reinforcement bars of the Founkama micro-dam dam (Photo. Babilas Hountondji, 2026).
